# Inspection Report

**Property Address:**  
1234 Your New Home Way  
738-4041 Call TODAY  
Las Vegas NV 89101

**Las Vegas Inspection Services, LLC**

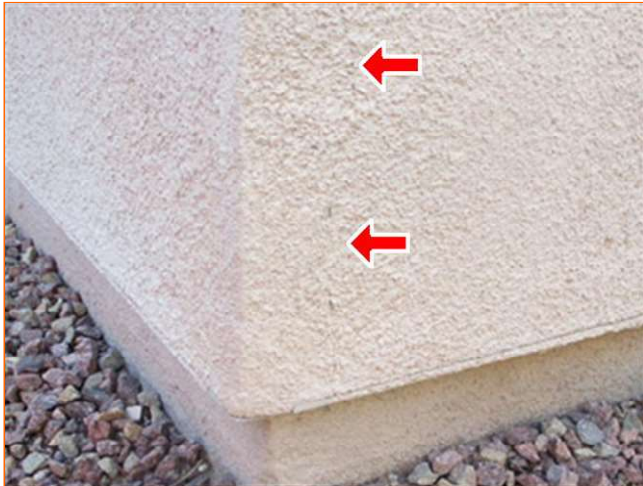
1.5 Item 1(Picture)

(1) Hairline cracks observed. These are common in cement based stucco siding, however moisture may penetrate these cracks. Recommend sealing/repair cracks by qualified professional.

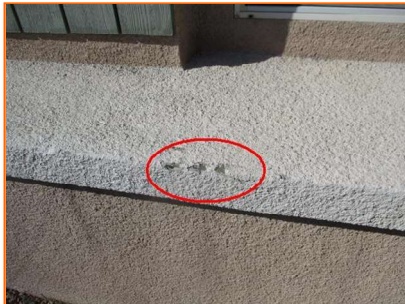
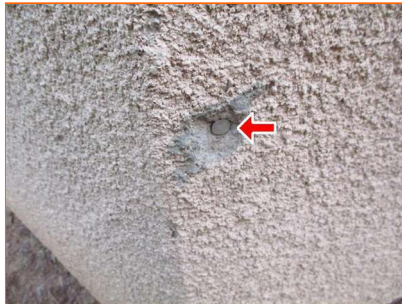
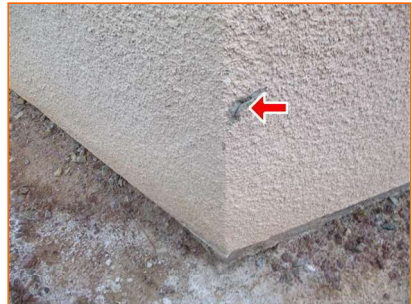
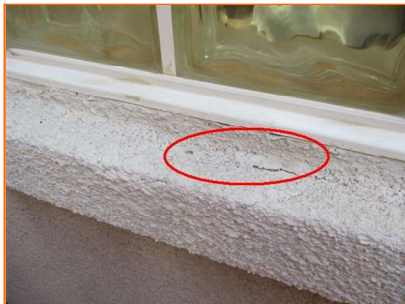
(2) Holes in siding at front window well, rear left corner and left side window trim (facing front). Recommend repair by a qualified professional.

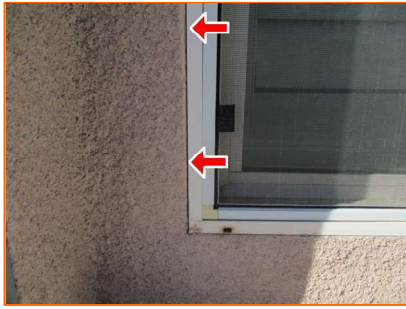
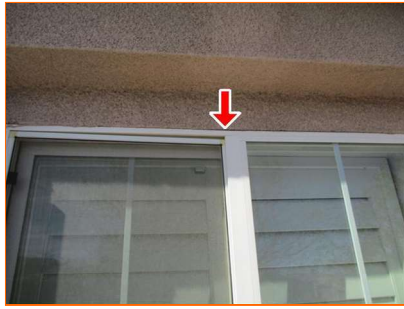
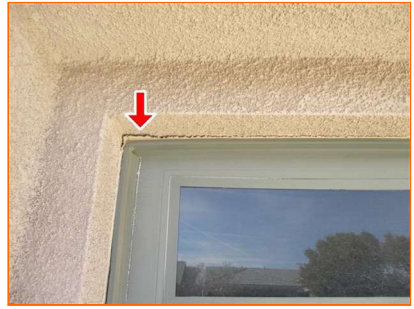
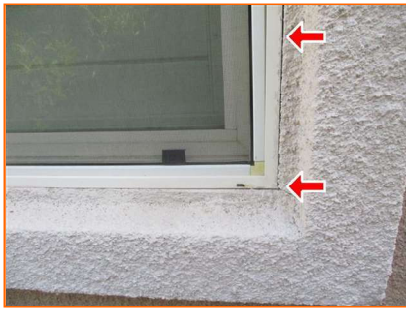
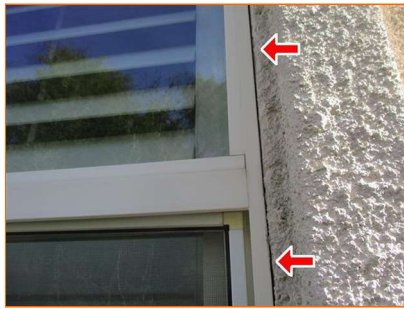
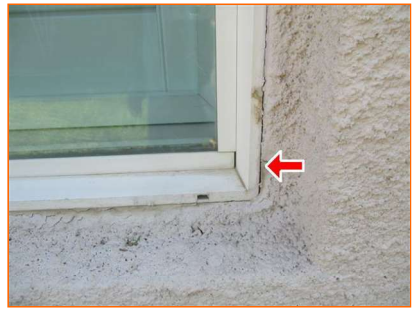
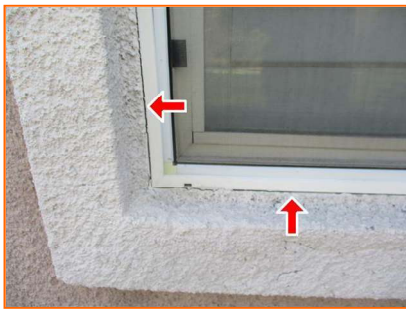
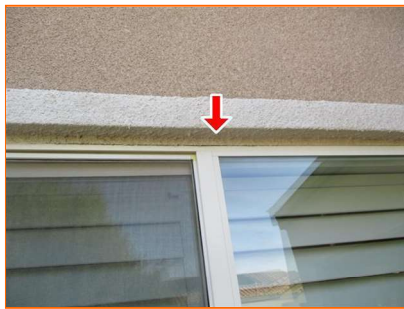
Gaps observed between window and sliding door frames where stucco abuts frames at several locations. The windows are vinyl framed abutted against cement based stucco, the gaps are within tolerance and windows open with little/no tightness in the frame. Recommend sealing gaps by a qualified person to prevent pest/moisture intrusion.

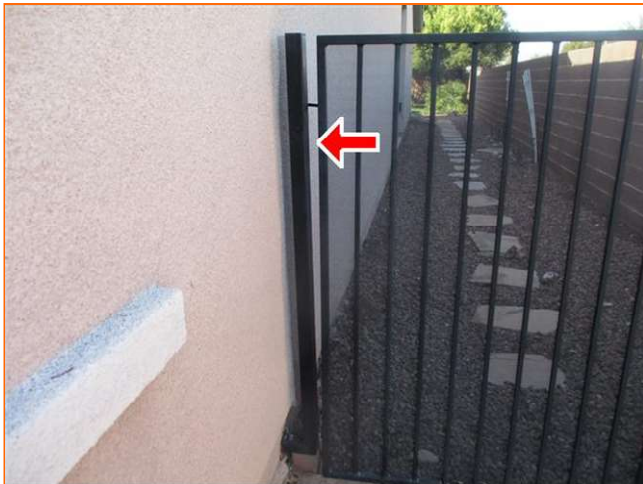
1.8 Item 1(Picture)

(1) Gate post is loose, no upper support. Recommend repair/securing by a qualified professional.

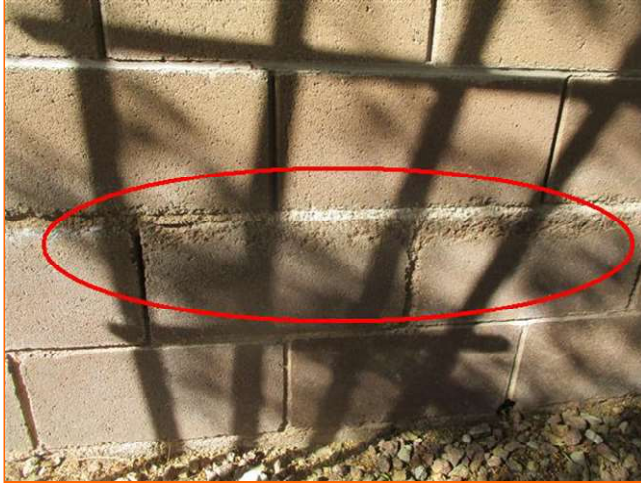
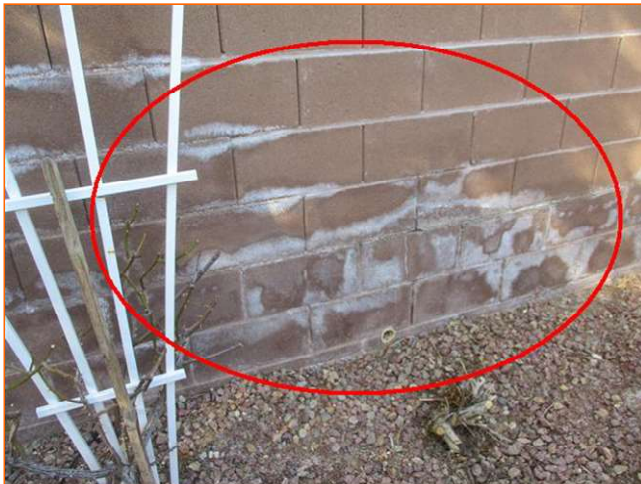
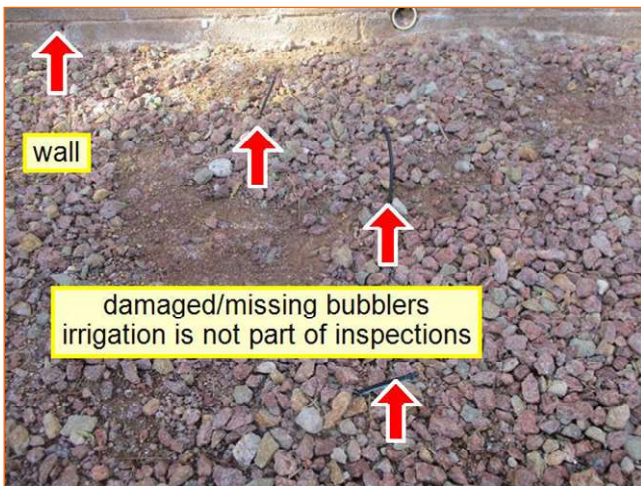
(3) Minor deterioration and white build-up at perimeter rear walls. Recommend directing sprinklers away from walls, clean white build-up as this may further damage the walls. Monitoring for change in condition.

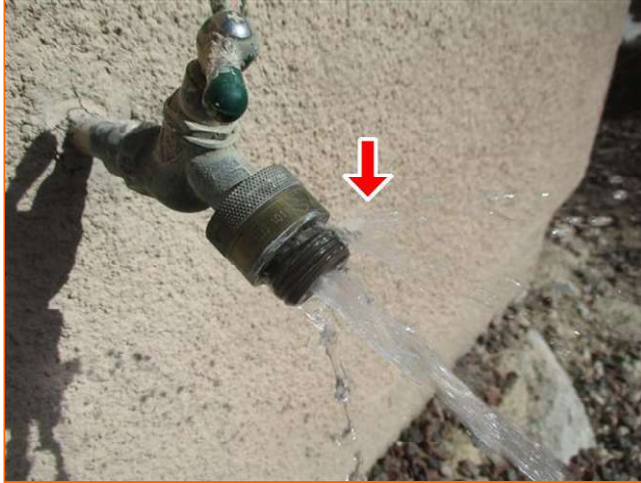
1.10 Item 1(Picture)

Anti-siphon is defective at front of home. Recommend replacement by a qualified person / contractor.

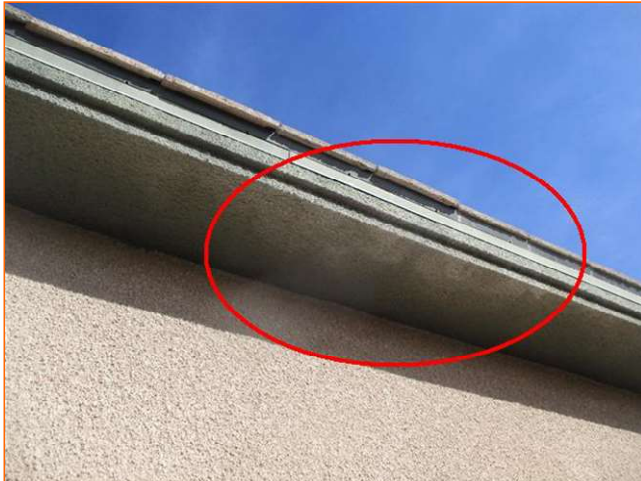
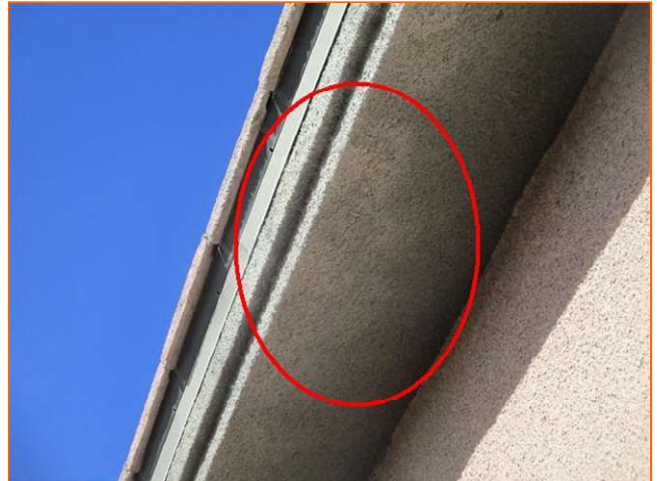
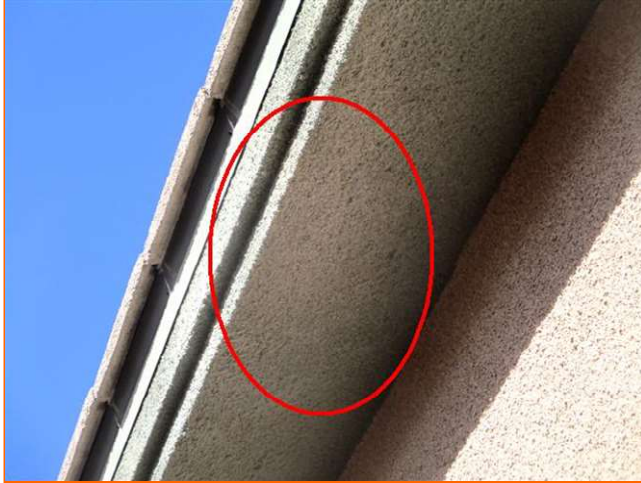
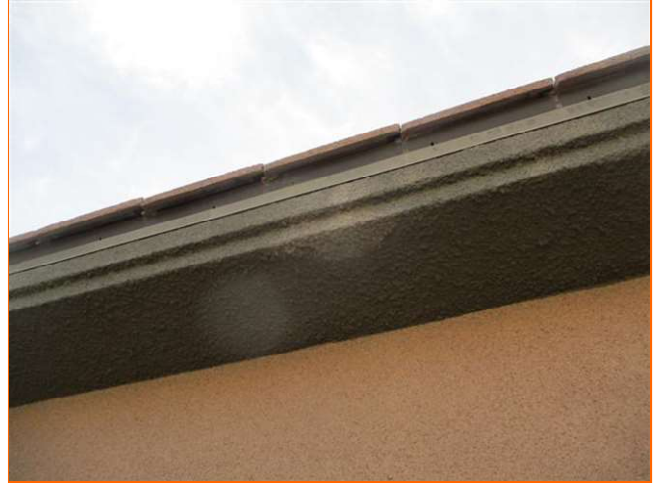
(1) Moisture stains at underside of eaves at various locations. Seal/paint and monitor for change in condition. See following comment for more information, the cracks maybe the cause however. Recommend evaluation and repair by a qualified professional/licensed contactor.

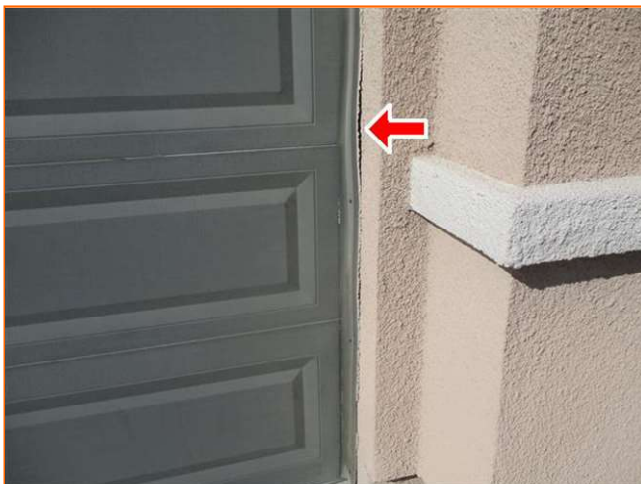
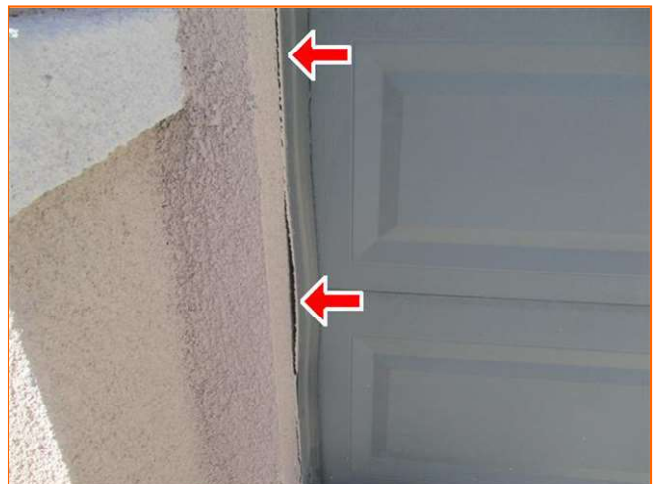
Door insulation is separated around door. Recommend repair or replace by a licensed contractor.

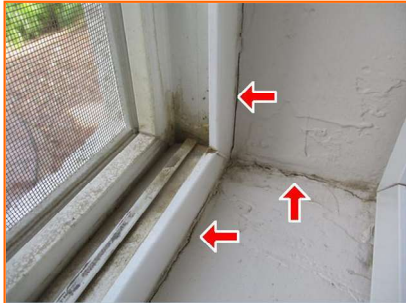
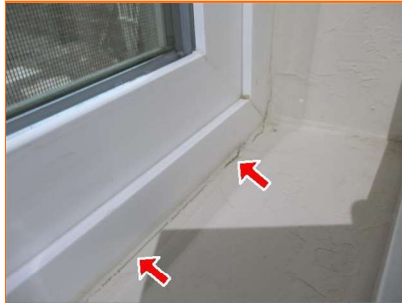
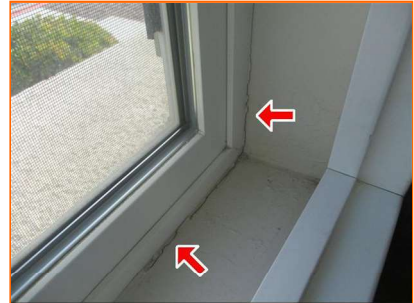
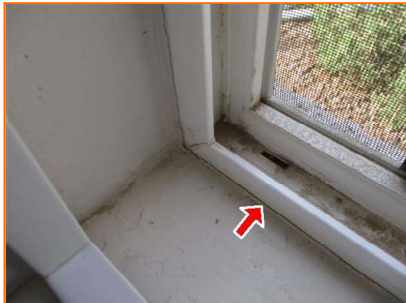
Separation around windows at seals. Recommend sealant for energy efficiency and prevent of pest intrusion.

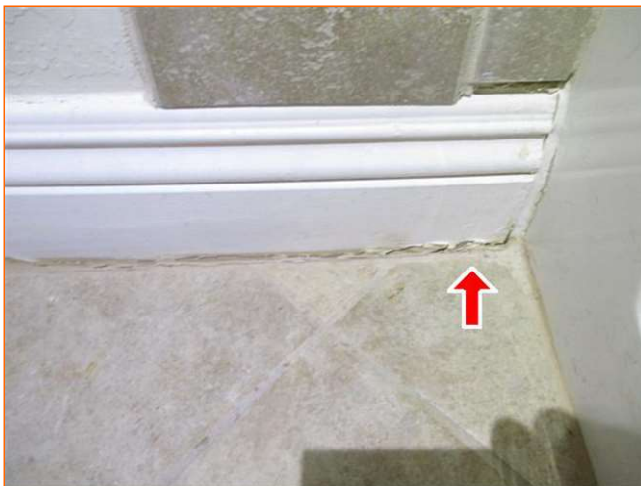
5.3 Item 1(Picture)

(1) Caulking is missing at Hall bathroom baseboards. Caulk helps prevent moisture penetration from splashed water and overflow. Recommend repair by a qualified professional.

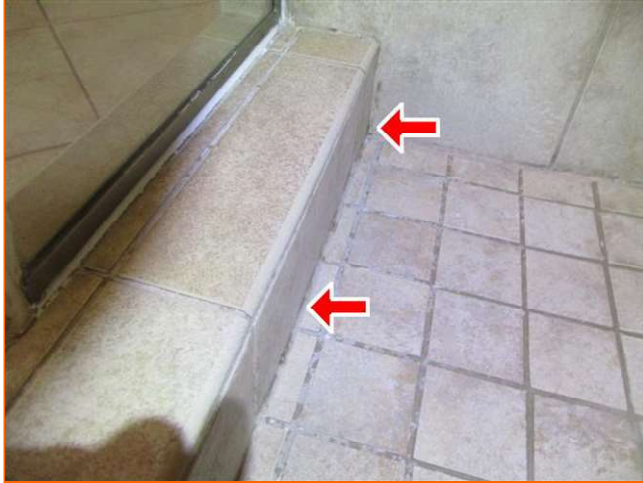
5.3 Item 2(Picture)

(2) Clear caulking is installed over mildewed old caulking, this is not professionally installed. Recommend strip and proper caulking at shower walls and around Master bathroom shower.

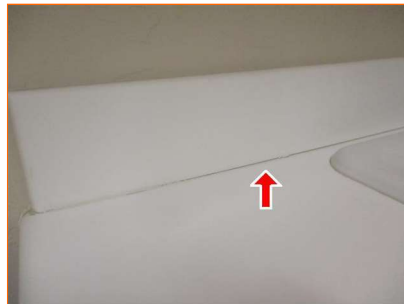
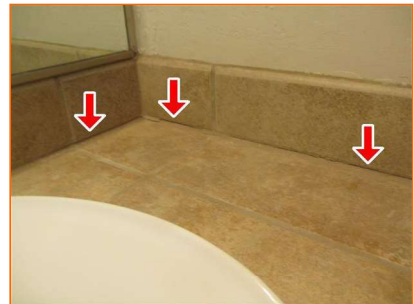
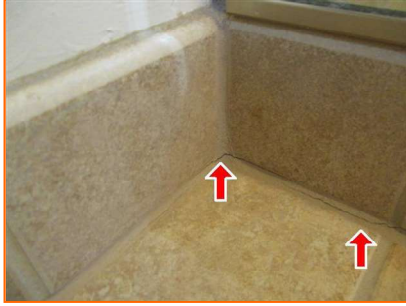
Repair and maintain caulking at Laundry Room and Master Bathroom countertop(s).

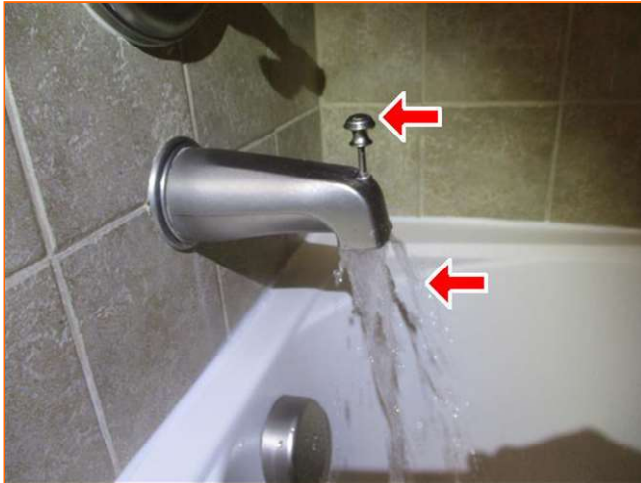
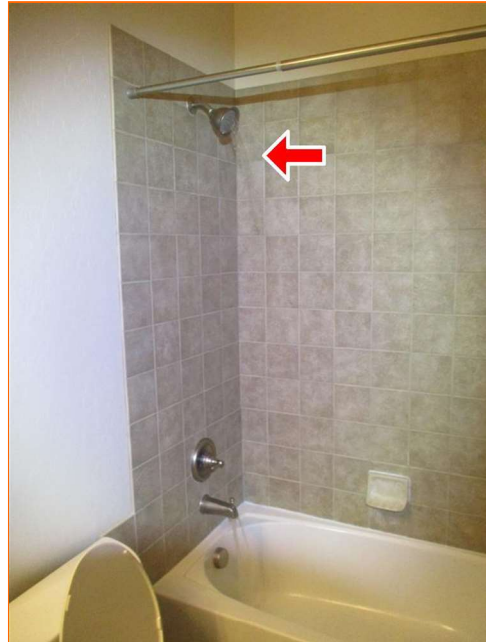
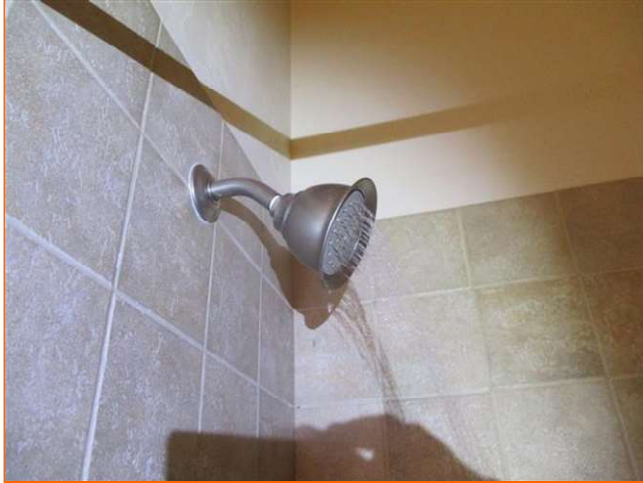
(1) Tub diverter does not fully divert flow to shower head at Hall Bath. Pressure is adequate at this time however, condition will worsen with age. Monitor for future repair.

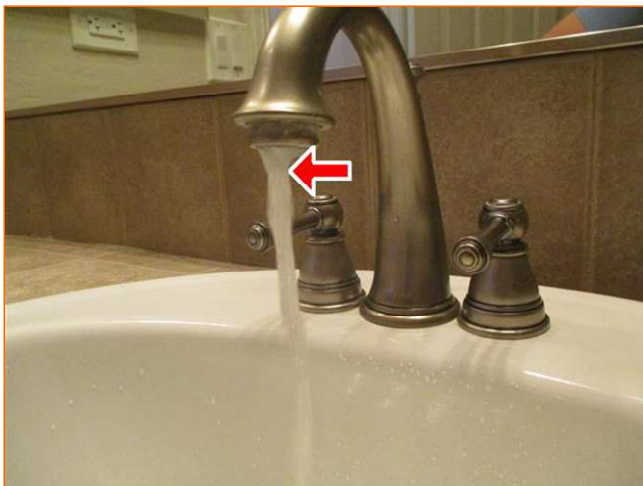
6.3 Item 4(Picture)

(2) Low water volume observed at Half bathroom and Hall bathroom sinks and Master bathroom, left and right side sinks. While this maybe the aerator filters at the fixtures, it is my experience that this occurs when something is wrong with the water softener. I do not inspect water softeners/water quality. Recommend further evaluation by a qualified professional.

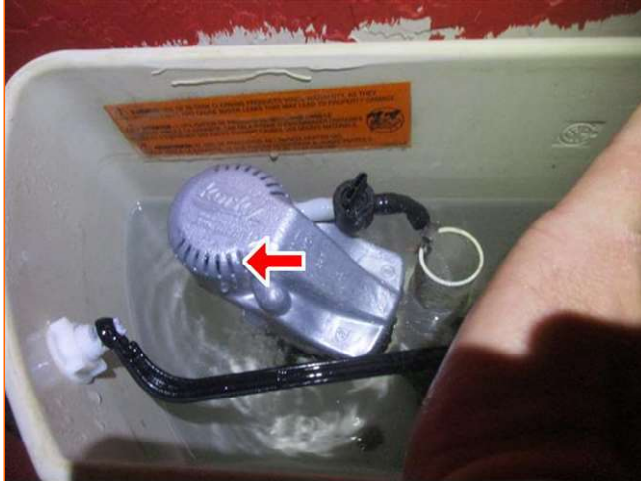
6.4 Item 1(Picture)

Toilet in Half Bath does not flush properly, intermittent fill and spray from flush valve device. Recommend repair by a licensed contractor.

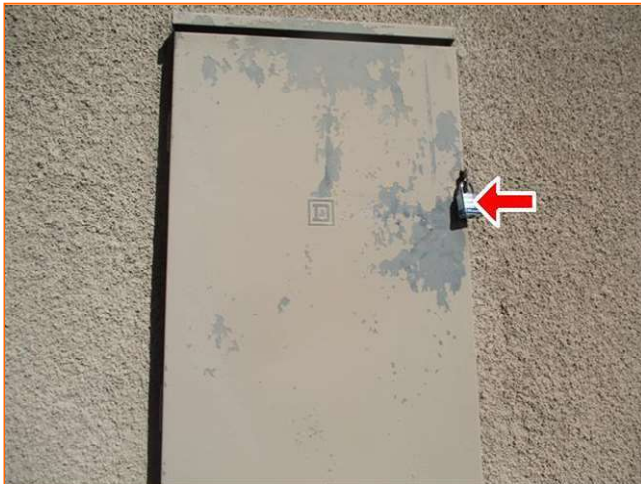
7.3 Item 1(Picture)

Main panel is locked. Recommend removing lock for inspection.

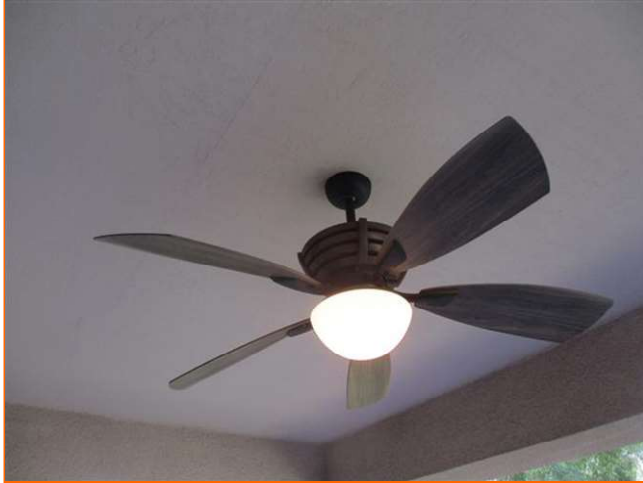
7.4 Item 1(Picture)

(1) Fan makes unusual noise at rear patio. Recommend repair or replacement by a licensed contractor.

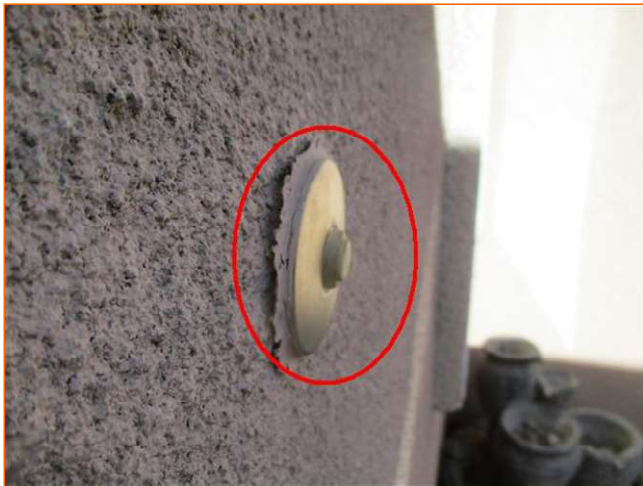
7.4 Item 3(Picture)

(2) Loose doorbell button, adjust as needed by a qualified person.

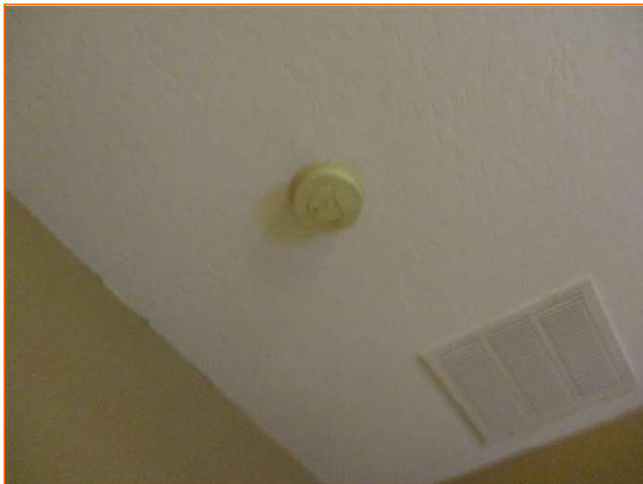
7.7 Item 1(Picture)

Consider replacing smoke detectors over 10 years of age, per manufacturers' recommendations. Additionally, current standards include Carbon Monoxide detection and units in all sleeping areas. Your safety is worth it!

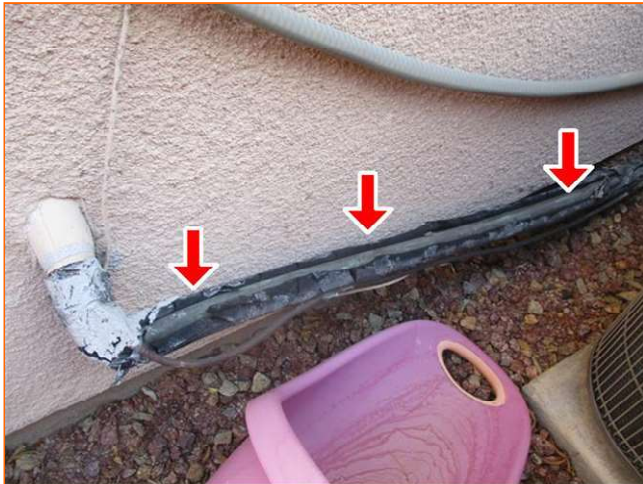
8.0 Item 1(Picture)

(2) Insulation at exterior unit is damaged or missing, this can effect efficiency and shorten the life of the unit. Recommend repairing / replacing insulation.

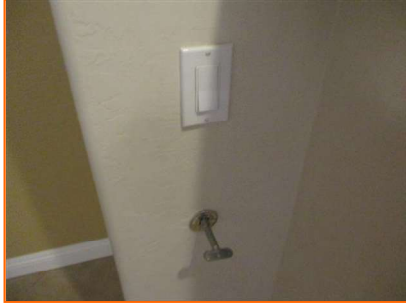
9.8 Item 1(Picture)

Fireplace did not ignite when switched ON and safety device/flue open. Recommend evaluation by a qualified professional/fireplace expert.

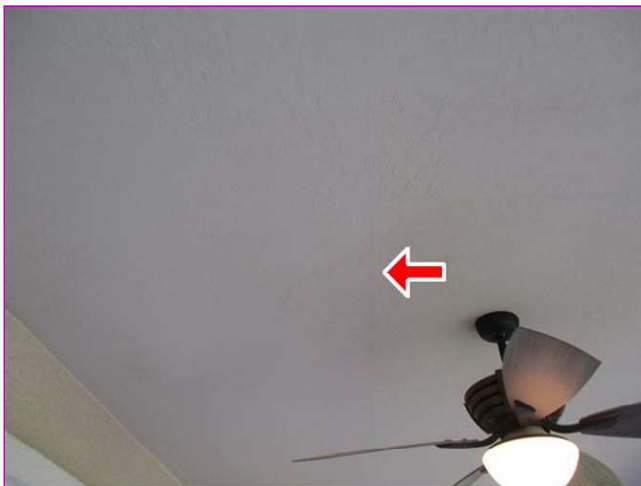
1.5 Item 6(Picture)

(3) Hairline cracks at rear need repair patio cover ceiling. Recommend repair as needed by a qualified professional / licensed contractor.

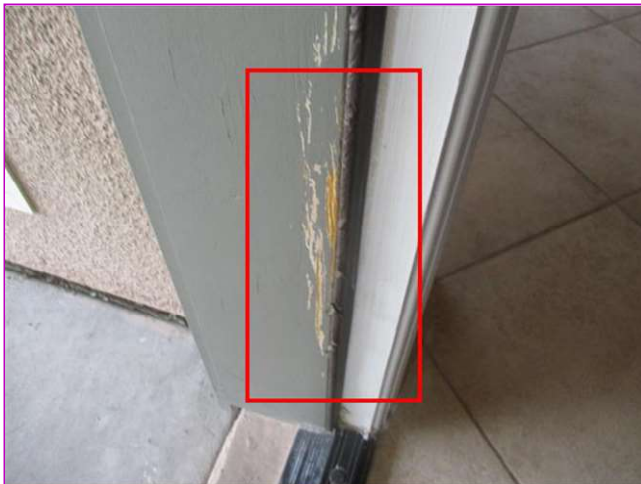
1.5 Item 7(Picture)

(4) Pet damage at rear patio door. Recommend sealing/painting frame and replacing insulation as needed.

**1.5 (4)** Pet damage at rear patio door. Recommend sealing/painting frame and replacing insulation as needed.

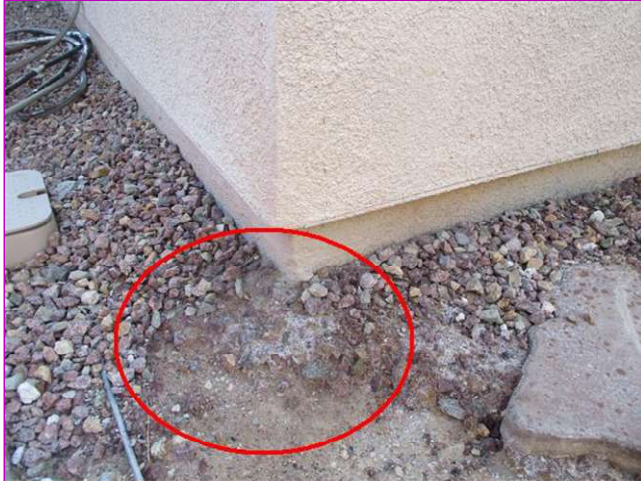
11.0 Item 1(Picture)

Recommend improving drainage at the building corners, front and rear. Adding rock/dirt to cover concrete over-pour will help to prevent settling that may cause damage.

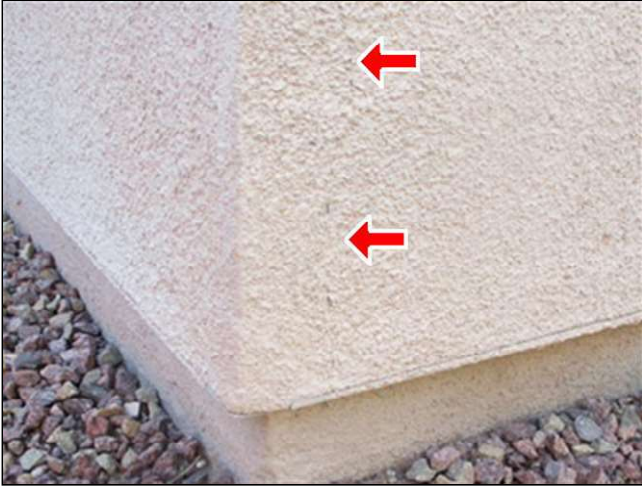
1.5 Item 1(Picture)

**1.5 (1)** Hairline cracks observed. These are common in cement based stucco siding, however moisture may penetrate these cracks. Recommend sealing/repair cracks by qualified professional.

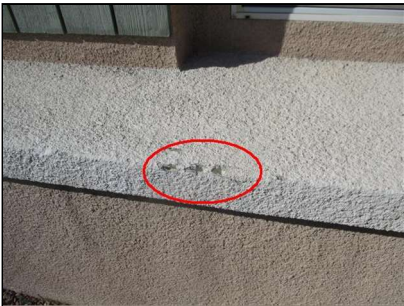
1.5 Item 2(Picture)

**1.5 (2)** Holes in siding at front window well, rear left corner and left side window trim (facing front). Recommend repair by a qualified professional.

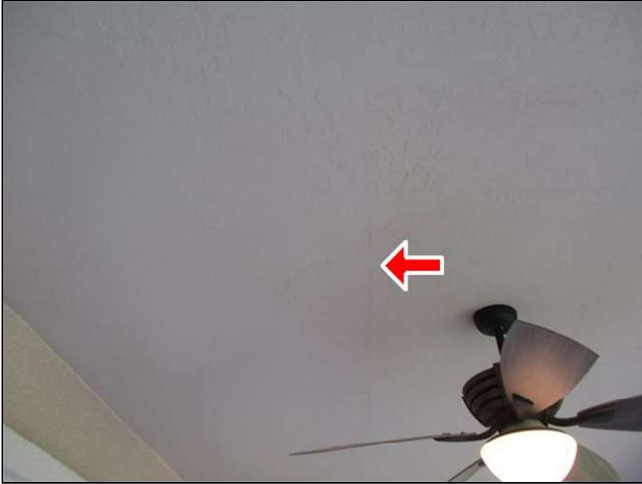
1.5 Item 6(Picture)

**1.5 (3)** Hairline cracks at rear need repair patio cover ceiling. Recommend repair as needed by a qualified professional / licensed contractor.

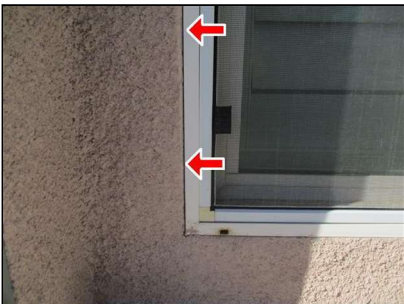
1.6 Item 1(Picture)

**1.6** Gaps observed between window and sliding door frames where stucco abuts frames at several locations. The windows are vinyl framed abutted against cement based stucco, the gaps are within tolerance and windows open with little/no tightness in the frame. Recommend sealing gaps by a qualified person to prevent pest/moisture intrusion.

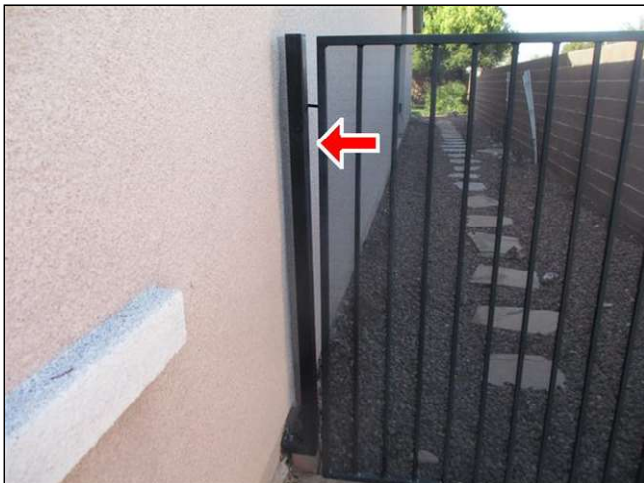
1.8 Item 1(Picture)

**1.8 (1)** Gate post is loose, no upper support. Recommend repair/securing by a qualified professional.

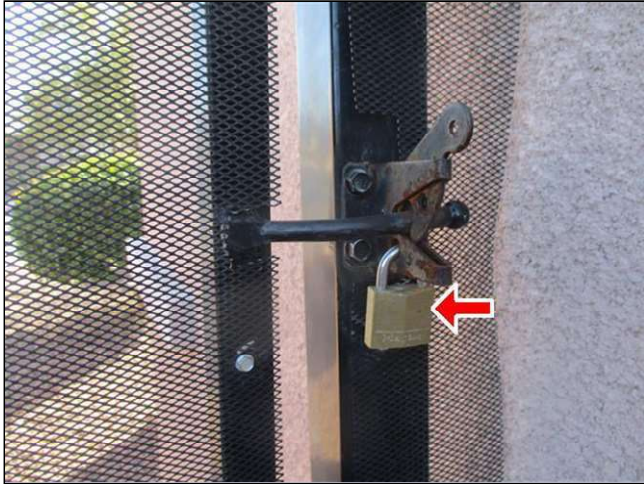
1.8 Item 2(Picture)

**1.8 (2)** Gate is locked check at walk-thru. Note: this lock appears hardened and maybe difficult to cut. Inquire about keys for locks. I checked all the Kitchen drawers and found only 1 extra house key, no padlock keys were found.

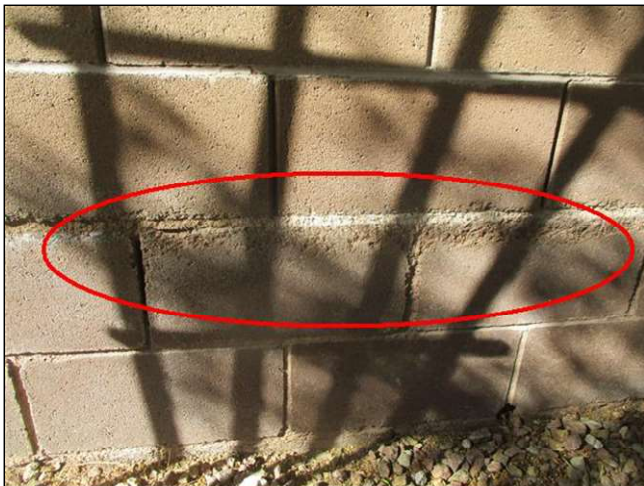
1.8 Item 3(Picture)

**1.8 (3)** Minor deterioration and white build-up at perimeter rear walls. Recommend directing sprinklers away from walls, clean white build-up as this may further damage the walls. Monitoring for change in condition.

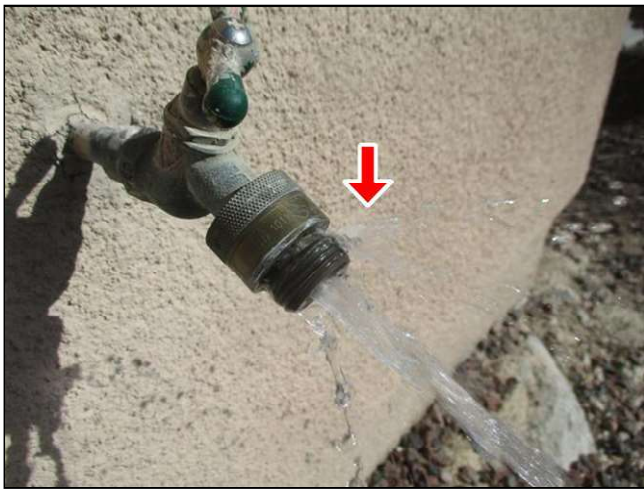
1.10 Item 1(Picture)

1.10 Anti-siphon is defective at front of home. Recommend replacement by a qualified person / contractor.

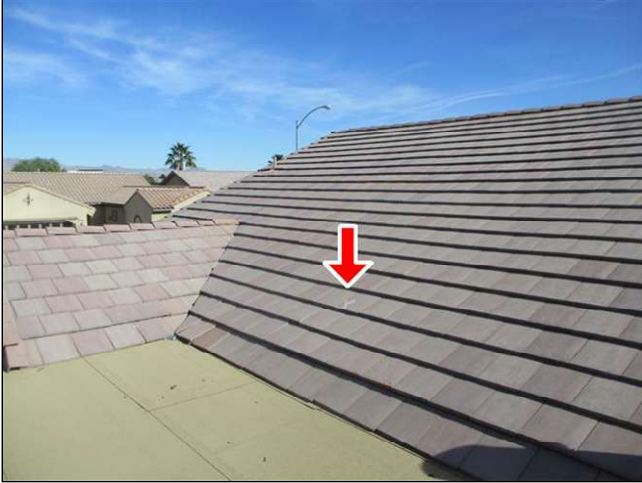
2.0 Item 1(Picture)

**2.0** Repaired tile at rear of home appears serviceable at this time. Monitor from time to time for damage.

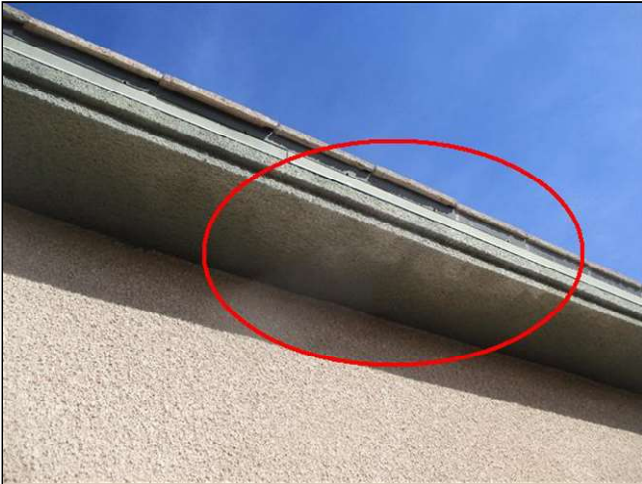
2.1 Item 1(Picture)

**2.1 (1)** Moisture stains at underside of eaves at various locations. Seal/paint and monitor for change in condition. See following comment for more information, the cracks maybe the cause however. Recommend evaluation and repair by a qualified professional/licensed contactor.

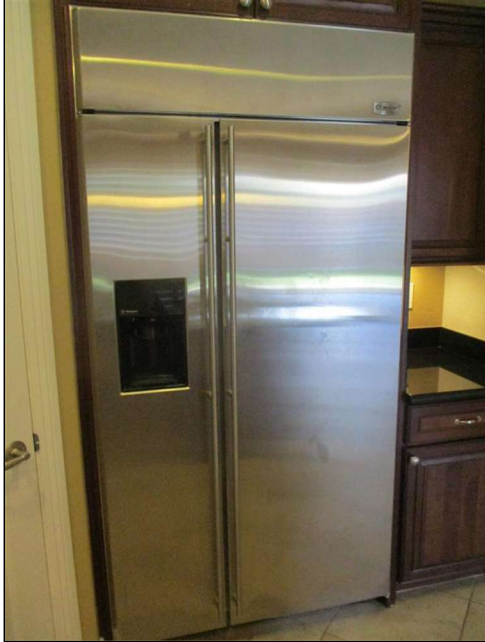
3.6 Item 1(Picture)

**3.6** Temperature sample / testing only, filters and water / ice makers are not part of this inspection.

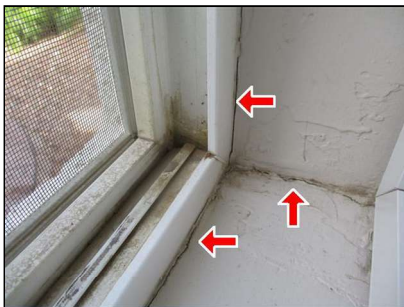
5.1 Item 1(Picture)

**5.1 Separation around windows at seals. Recommend sealant for energy efficiency and prevent of pest intrusion.**

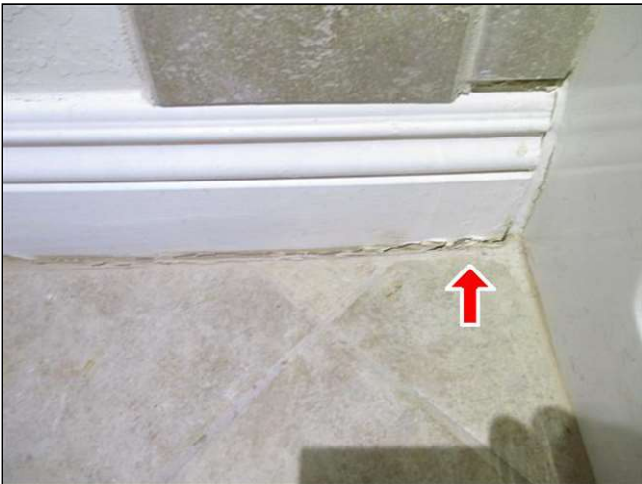
5.3 Item 1(Picture)

**5.3 (1)** Caulking is missing at Hall bathroom baseboards. Caulk helps prevent moisture penetration from splashed water and overflow. Recommend repair by a qualified professional.

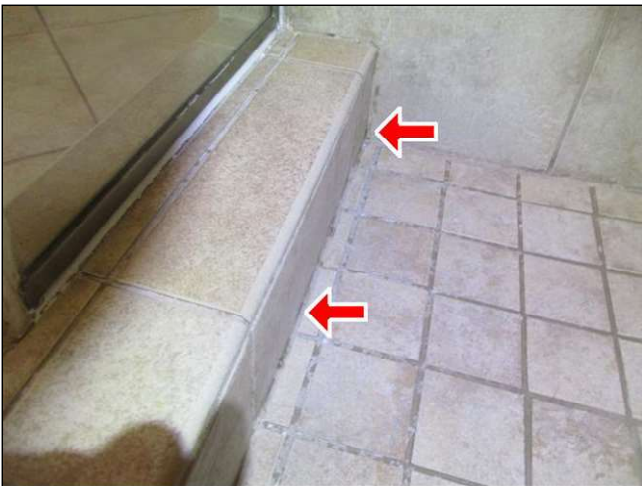
5.3 Item 2(Picture)

**5.3 (2)** Clear caulking is installed over mildewed old caulking, this is not professionally installed. Recommend strip and proper caulking at shower walls and around Master bathroom shower.

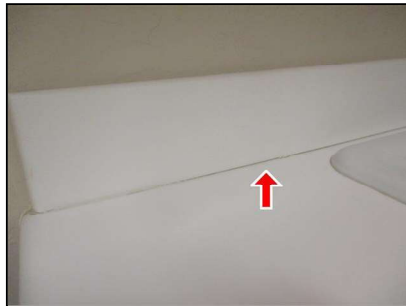
5.6 Item 2(Picture)

5.6 Repair and maintain caulking at Laundry Room and Master Bathroom countertop(s).

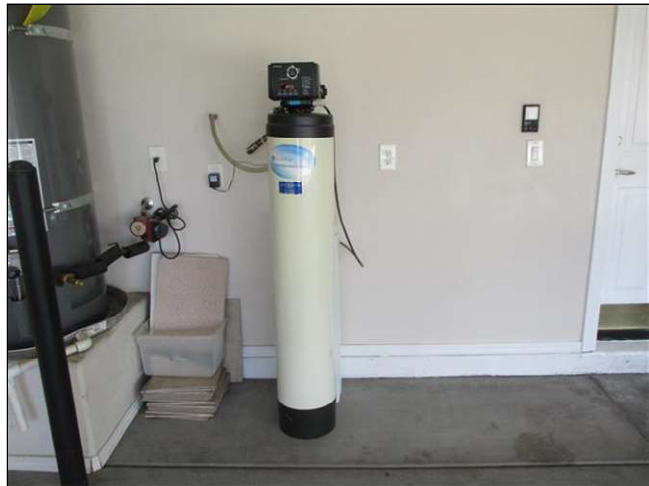
Water softener is not inspected

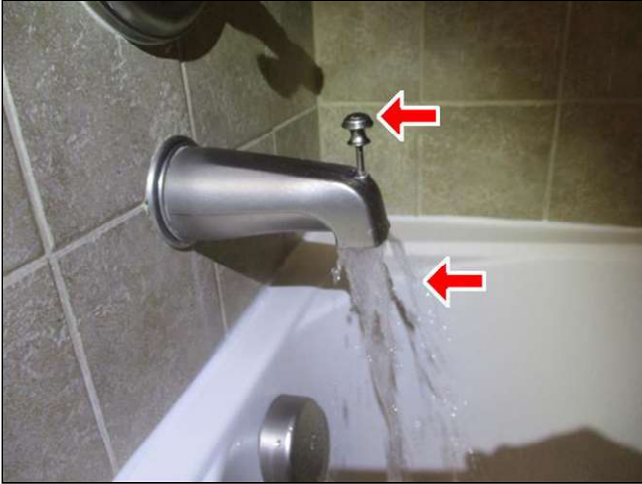
6.3 Item 1(Picture)

**6.3 (1)** Tub diverter does not fully divert flow to shower head at Hall Bath. Pressure is adequate at this time however, condition will worsen with age. Monitor for future repair.

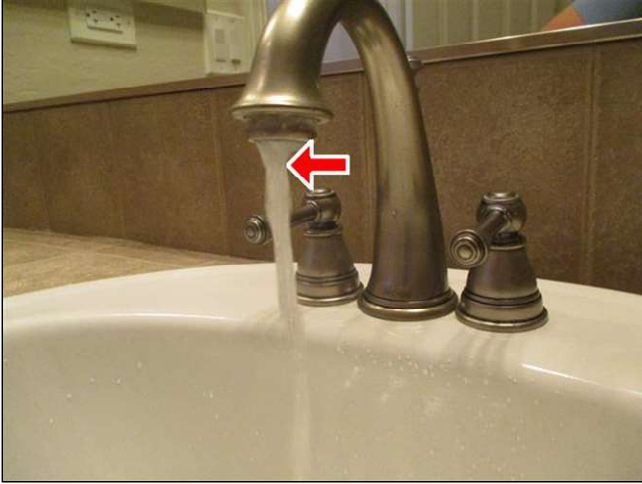
6.3 Item 4(Picture)

**6.3 (2)** Low water volume observed at Half bathroom and Hall bathroom sinks and Master bathroom, left and right side sinks. While this maybe the aerator filters at the fixtures, it is my experience that this occurs when something is wrong with the water softener. I do not inspect water softeners/water quality. Recommend further evaluation by a qualified professional.

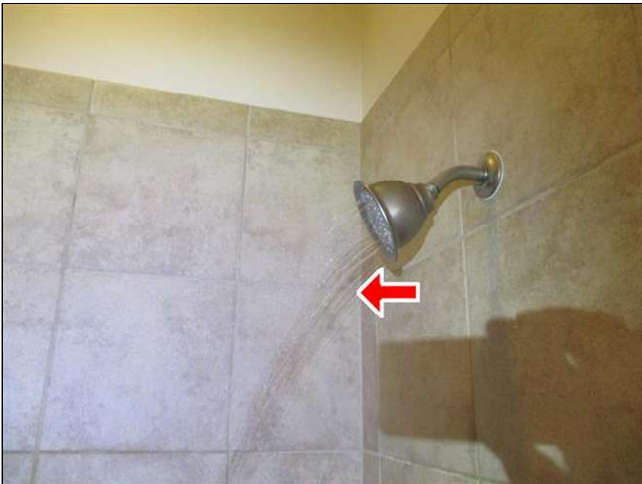
6.3 Item 6(Picture)

**6.3 (3)** Low water volume at Master bath shower when two fixtures are operating. See prior comment and evaluate with by qualified professional.

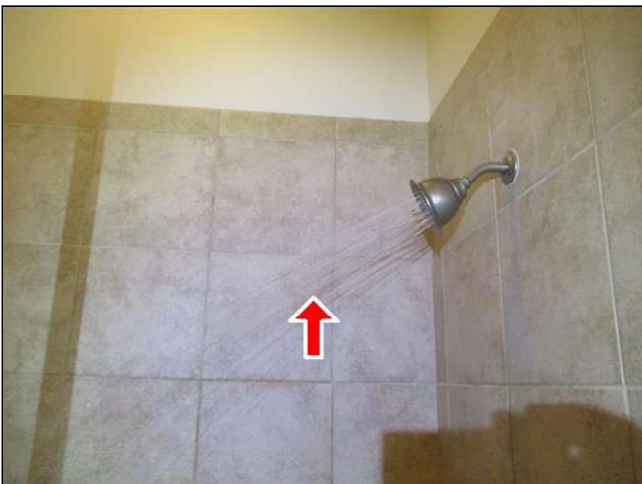
6.3 Item 8(Picture) With only one fixture in use

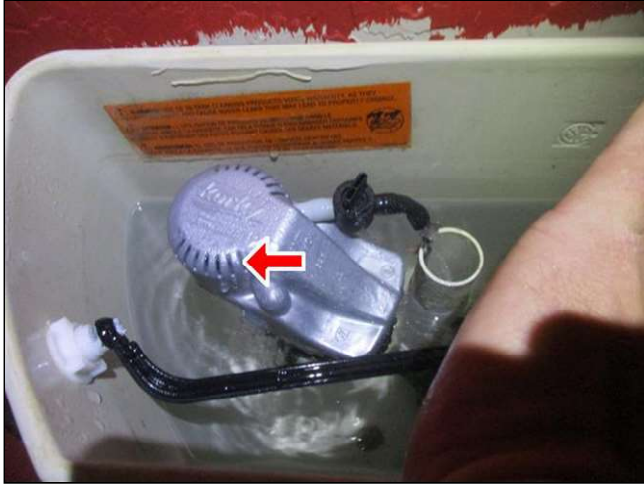
6.4 Item 1(Picture)

**6.4 Toilet in Half Bath does not flush properly, intermittent fill and spray from flush valve device. Recommend repair by a licensed contractor.**

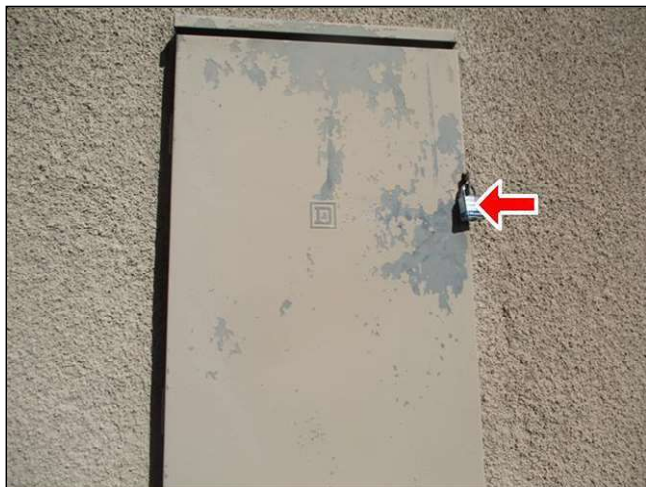
7.3 Item 1(Picture)

7.3 Main panel is locked. Recommend removing lock for inspection.

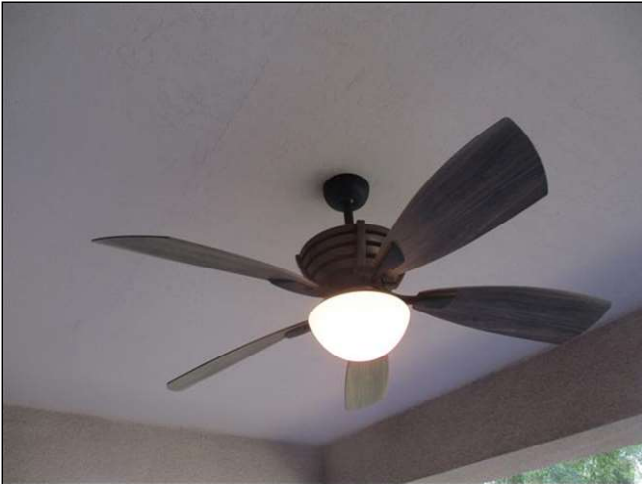
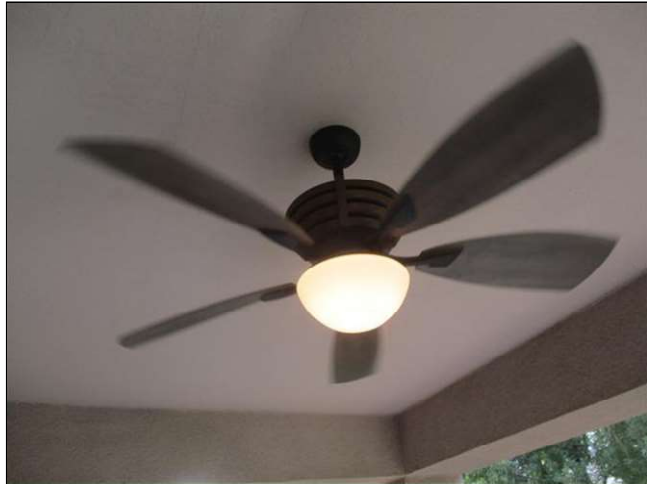
7.4 Item 1(Picture)

**7.4 (1) Fan makes unusual noise at rear patio. Recommend repair or replacement by a licensed contractor.**

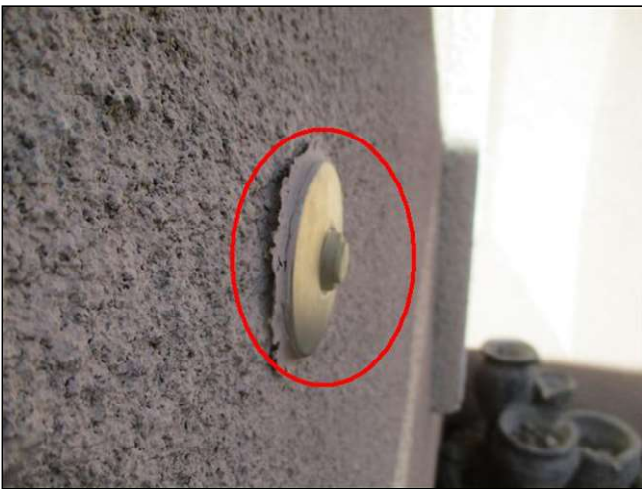
7.4 Item 3(Picture)

**7.4 (2) Loose doorbell button, adjust as needed by a qualified person.**

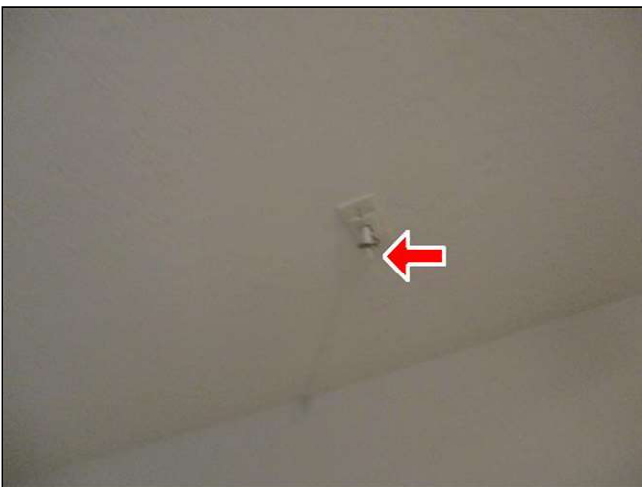
7.4 Item 4(Picture)

**7.4 (3) Low voltage is not inspected. Surround sound speaker wires are hanging in Living room.**

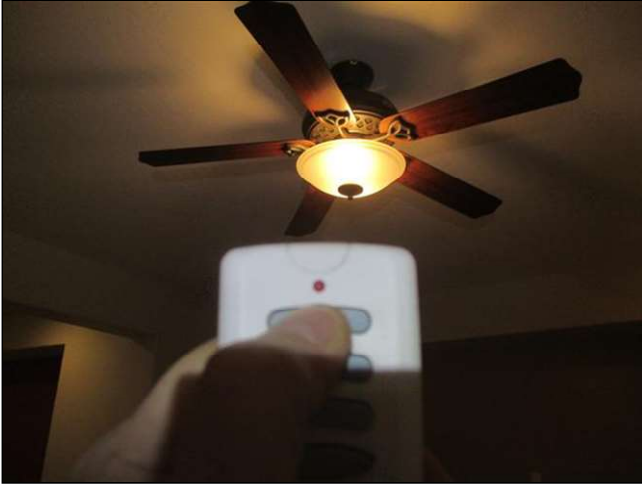
7.4 Item 6(Picture)

**7.4** (4) Fan remote non-operational at Living Room, batteries may have no charge. Recommend repair or replacement by a licensed contractor.

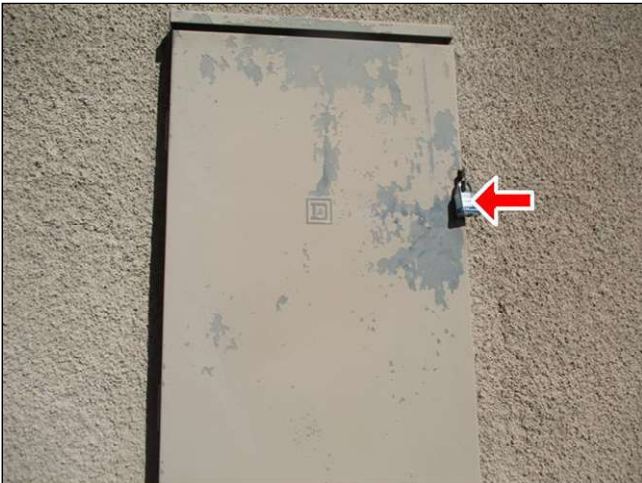
7.5 Item 1(Picture)

**7.5** Main panel is locked, AFCI breakers were not inspected. Recommend removing lock for inspection.

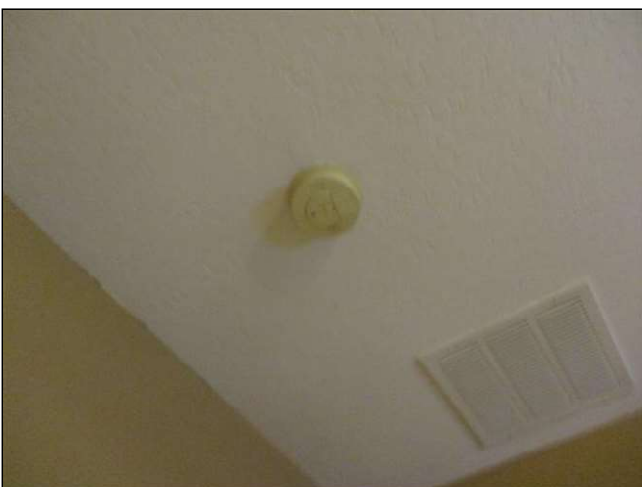
7.7 Item 1(Picture)

**7.7** Consider replacing smoke detectors over 10 years of age, per manufacturers' recommendations. Additionally, current standards include Carbon Monoxide detection and units in all sleeping areas. Your safety is worth it!

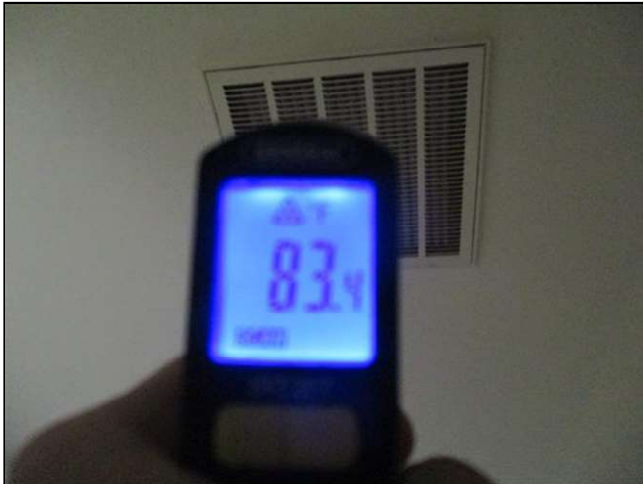
Ambient air IN

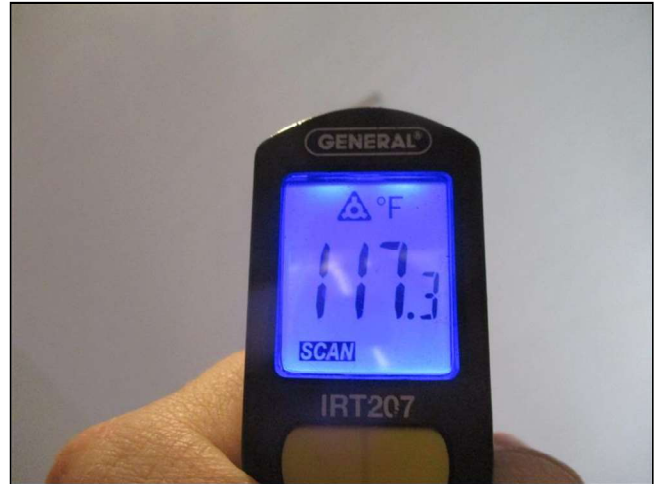
Heated air OUT

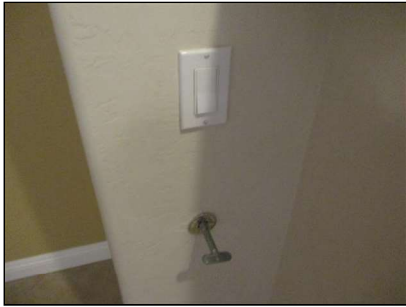
9.8 Item 1(Picture)

9.8 Fireplace did not ignite when switched ON and safety device/flue open. Recommend evaluation by a qualified professional/fireplace expert.
