# Inspection Report

**Property Address:**  
1234 Your New Home Way  
738-4041 Call TODAY  
Las Vegas NV 89101

**Las Vegas Inspection Services, LLC**

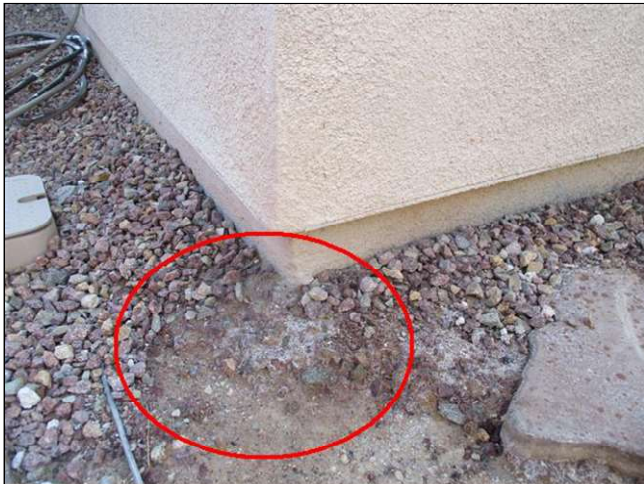
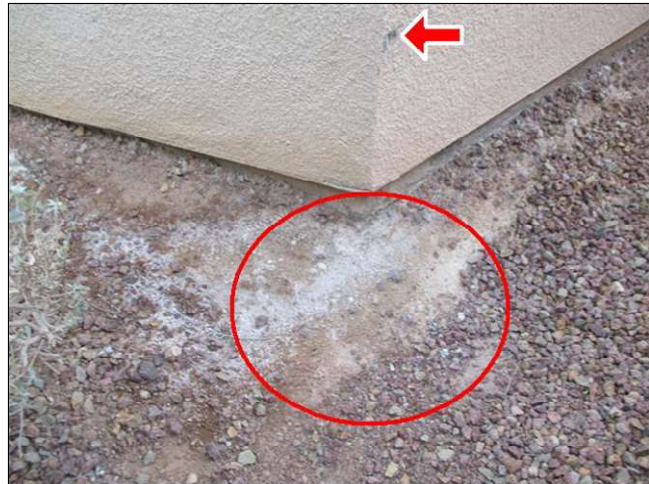
11.0 Item 1(Picture)

**11.0** Recommend improving drainage at the building corners, front and rear. Adding rock/dirt to cover concrete over-pour will help to prevent settling that may cause damage.
